Chennai Floods, 2015

[A Satellite and Field Based Assessment Study]

Disaster Management Support (DMS) Division
National Remote Sensing Centre
(NRSC / ISRO)
Hyderabad, India

5.	Document Control Number	NRSC-RSAA-DMSG-June-2016-TR-863			
6.	Title	Chennai Floods, 2015 [A Satellite and Field Based Assessment Study]			
7.	Particulars of collation	Pages 34	Figures 34	Tables -	References 3

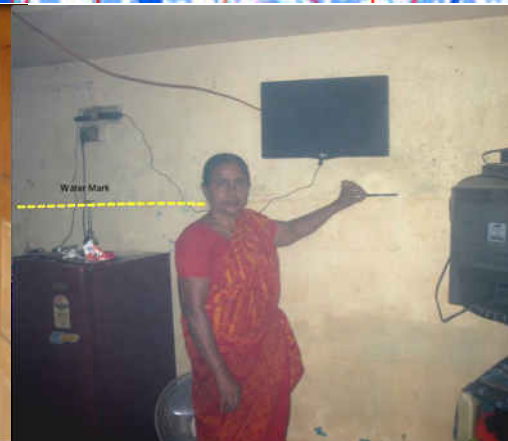
Ashok Nagar is a densely populated residential locality situated at the southern part of Chennai. It is located about 2 km north of Adyar River. Here the water depth was observed to be at 4.5 feet. Flood water marks outside the house on the window glasses, boundary walls and inside houses from the moisture content on the walls could be well visualized (Fig-14). The mud brought by water and clinging on to the window glasses and walls made a clear demarcation of the depth the flood water attained. Many cars drying outside in the sun was also a very common sight in this locality. The mud markings on the cars glasses at different levels as water receded could be clearly seen and inside the car fungus on the cars dashboard and mud filled inside can be seen (Fig-15). This area was under water for three days and thereafter the water slowly started receding.

Fig-14 Flood water marks on the wall, window and inside house observed in Ashok Nagar, 11th Avenue, Taurus Apartments. (c) NRSC/ISRO, 2015

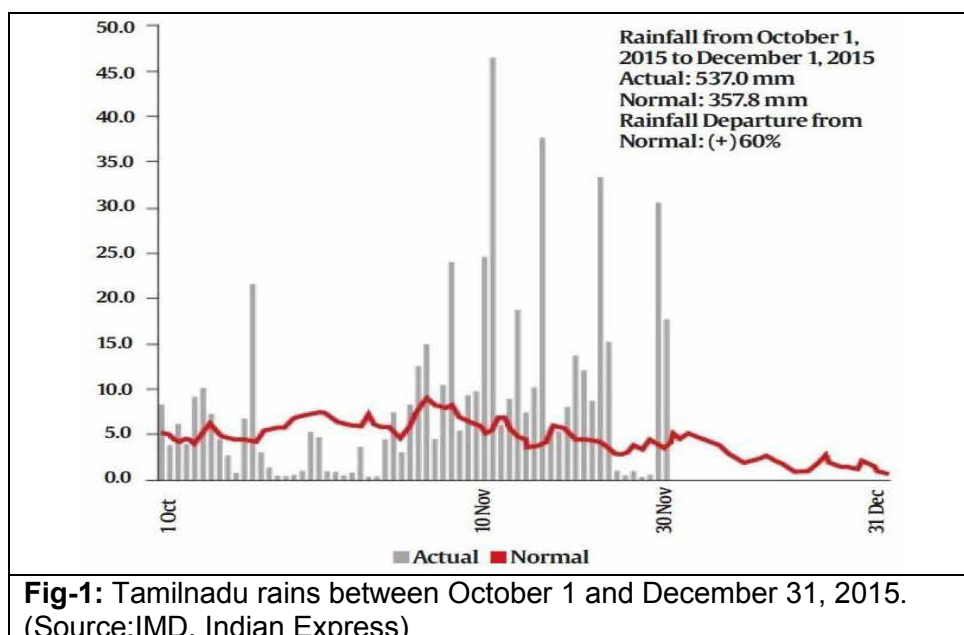
Fig-1: Tamilnadu rains between October 1 and December 31, 2015. (Source:IMD, Indian Express)

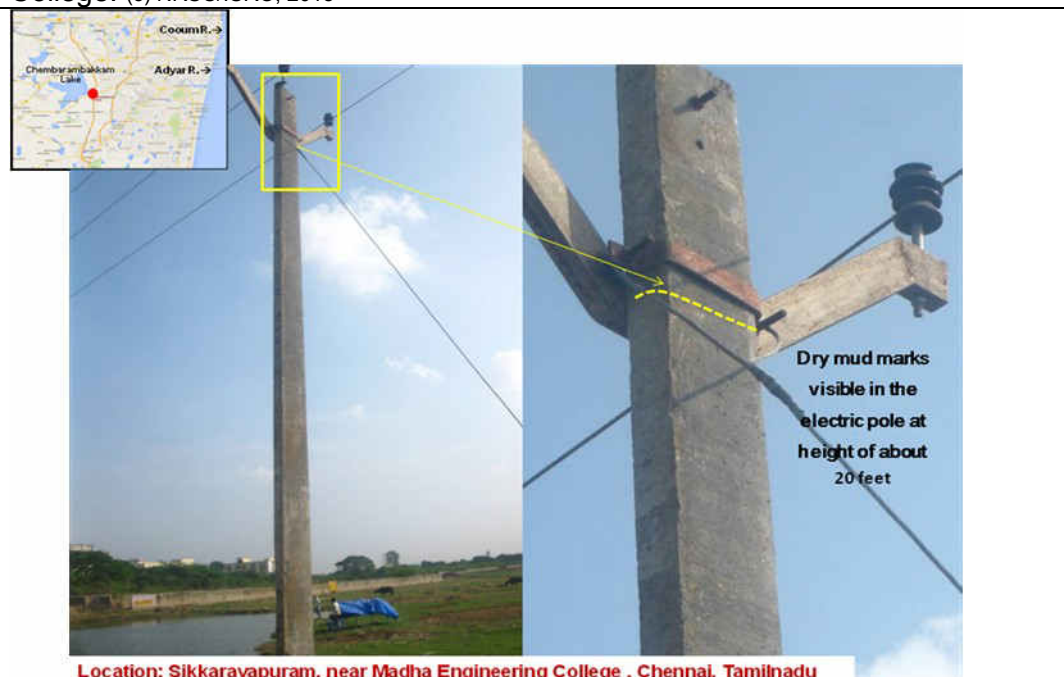
which would have passed through the area could be well imagined from the damages caused to the electricity poles, hoardings along roadside and road connectivity in that area (Fig-11). A closer look at the electric poles shows the mud marks indicates that the flood water at this location reached about 20 feet high on December 2, 2015 (Fig-12).

Fig-12 Layers of dried mud marks clinging to electric pole indicating height water attained on December 2, 2015 at Sikkarayapuram (Kancheepuram district) near, near Madha Engineering College. (c) NRSC/ISRO, 2015

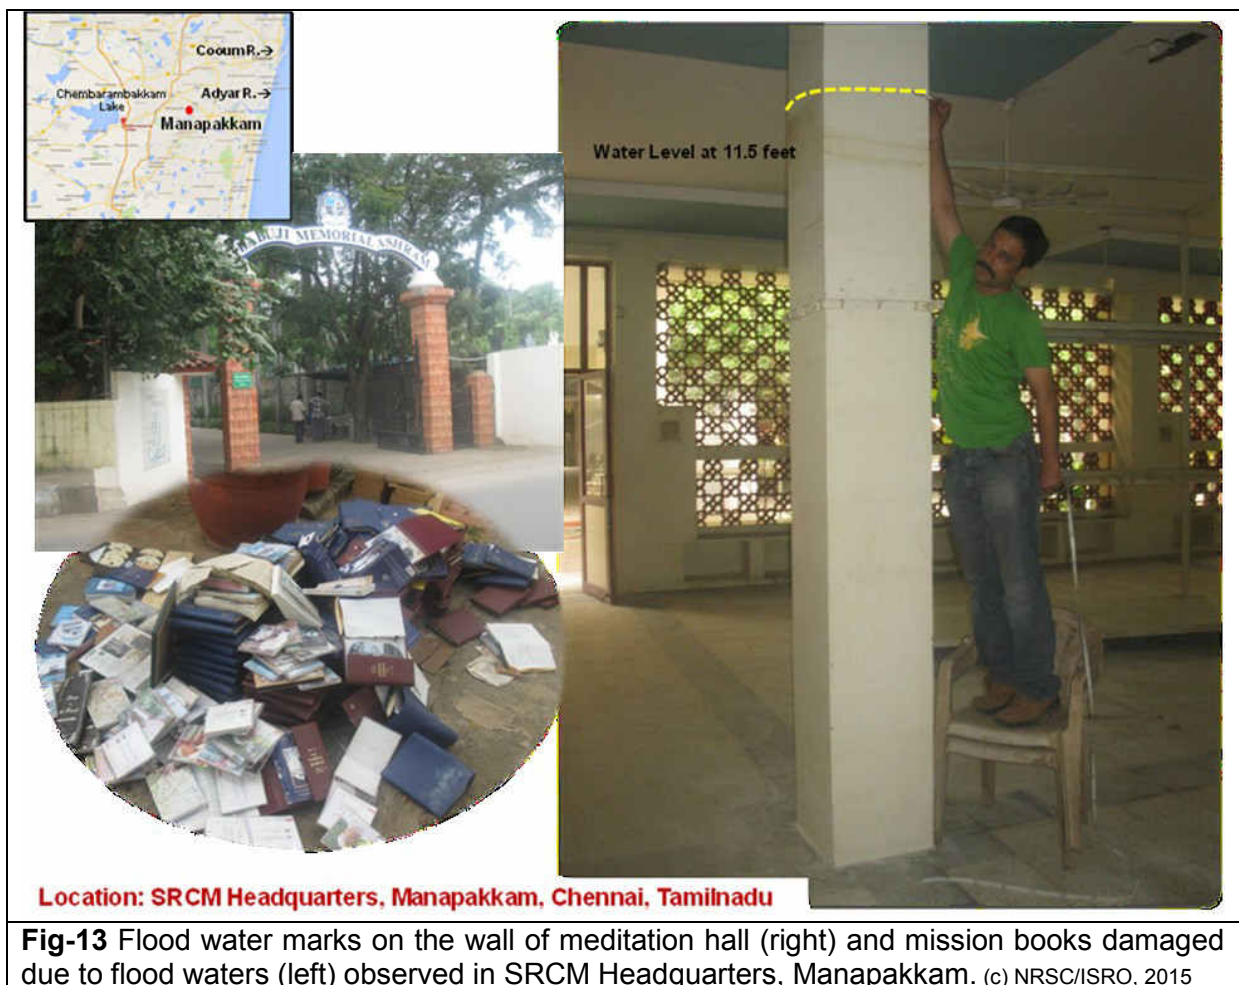
Manapakkam area is located 0.65km north of Adyar River and is one of the worse affected locations. During field inspection of the Sri Ram Chandra Mission (SRCM) world headquarters located in Manapakkam it was observed that the flood water depth in this area was about 11.5 feet. The website of SRCM mentions about occurrence of unparalled damage to the centre due to the flood waters (<https://www.sahajmarg.org/chennai-floods>). The centre staff told that water had entered the centre in the night of December 1, 2015 and the area was under water for almost 10 days and the water had to be drained out using pumps. The water marks left on the wall and pillars were clear enough to tell that everything would have submerged under 11.5 feet of water and on pillars the high water marks and marks left with recession were very much visible (Fig-13). Severe damage to books, kitchen, and meditation hall and furniture items was visible on inspection of the area.

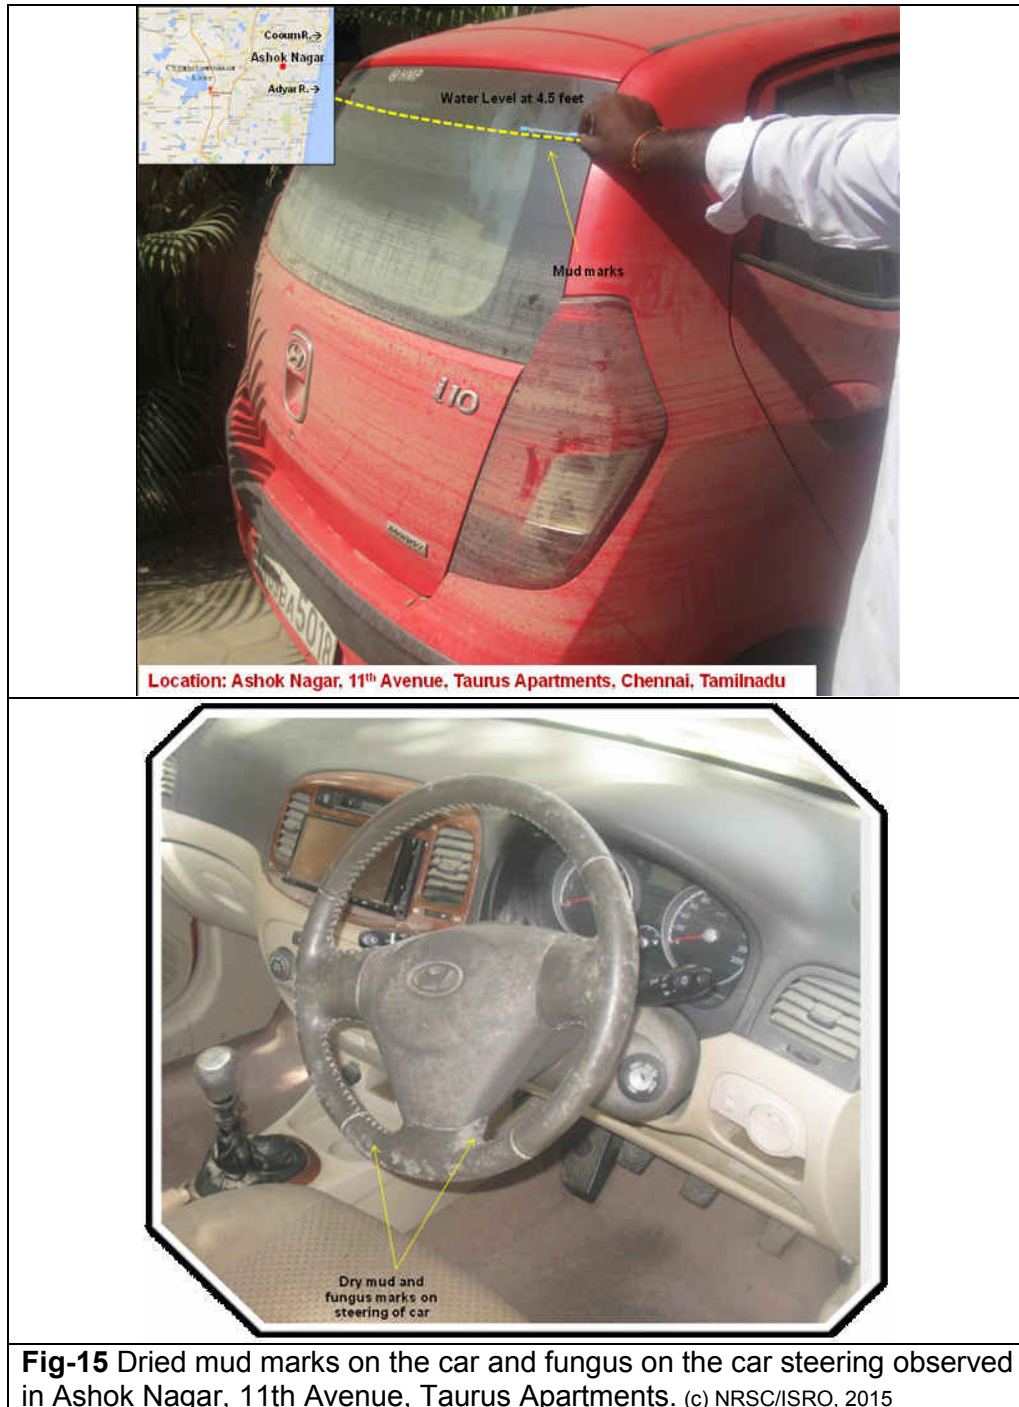
Fig-15 Dried mud marks on the car and fungus on the car steering observed in Ashok Nagar, 11th Avenue, Taurus Apartments. (c) NRSC/ISRO, 2015

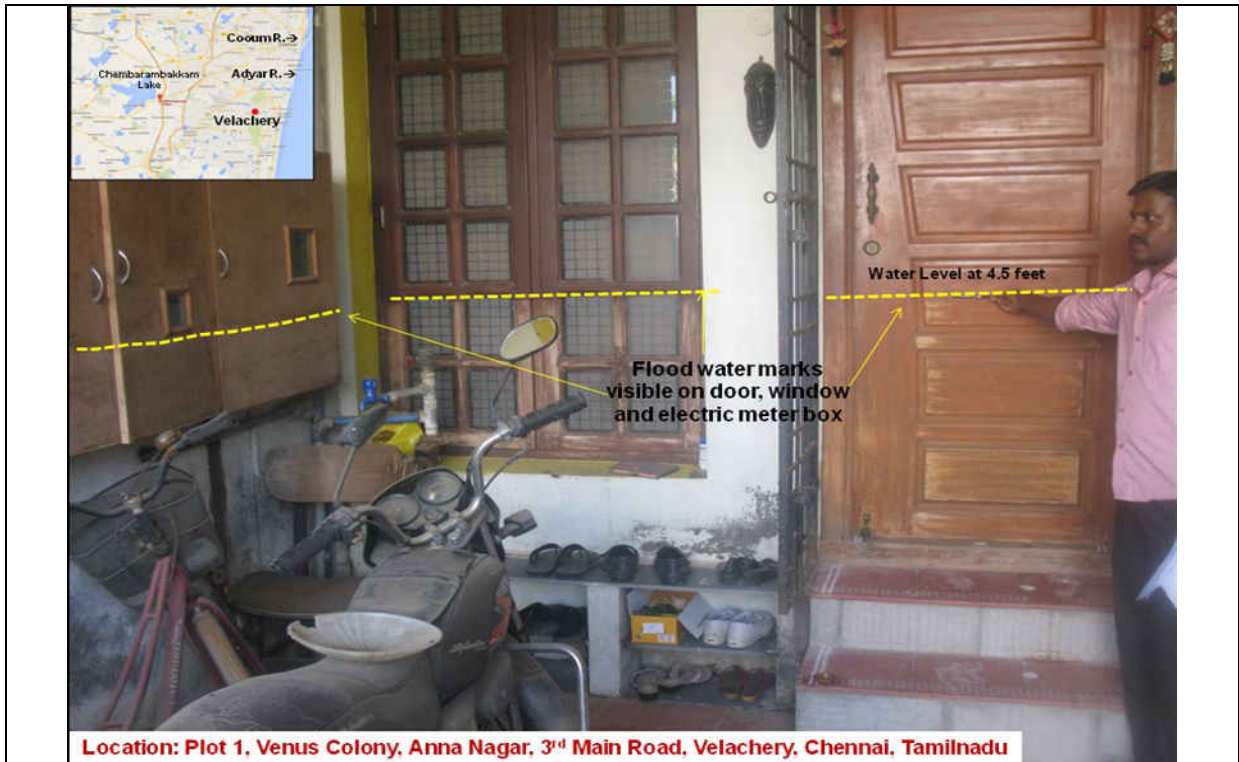
Fig-17 Flood water mark observed in doors, windows and electric metre box due to discolouration in one of the houses at Plot 1, Venus Colony, Anna Nagar, 3rd Main Road, Velachery. (c) NRSC/ISRO, 2015

- Velachery is one of those localities where water persisted for more than 10 days and average flood water depth in this area was about 4.5-5.5 feet. Colonies like Baby Nagar, Anna Nagar Extension and Venus Colony were worse affected. The discoloration of all houses doors and windows located in these localities due to stagnated water made the flooding impact distinct in this area (Fig 17-20).

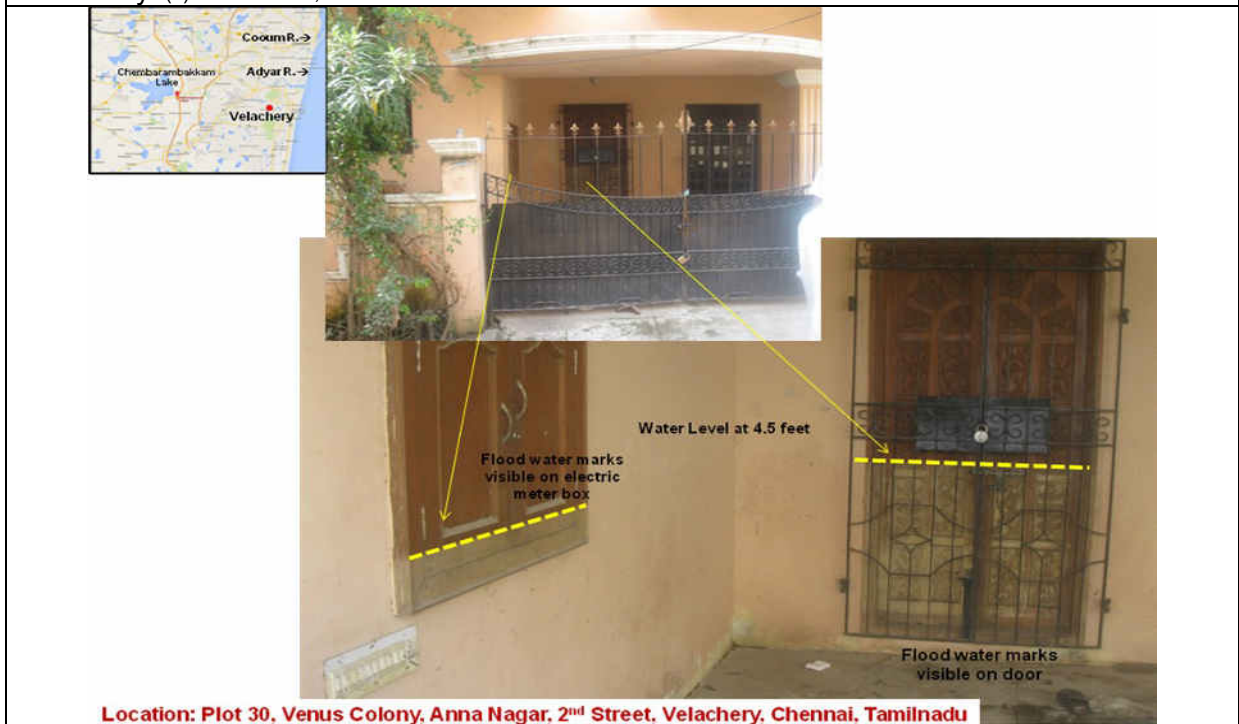
Fig-18 Flood water mark observed in doors, windows and electric metre box due to discolouration in one of the houses at Plot 30, Venus Colony, Anna Nagar, 2nd Street, Velachery. (c) NRSC/ISRO, 2015

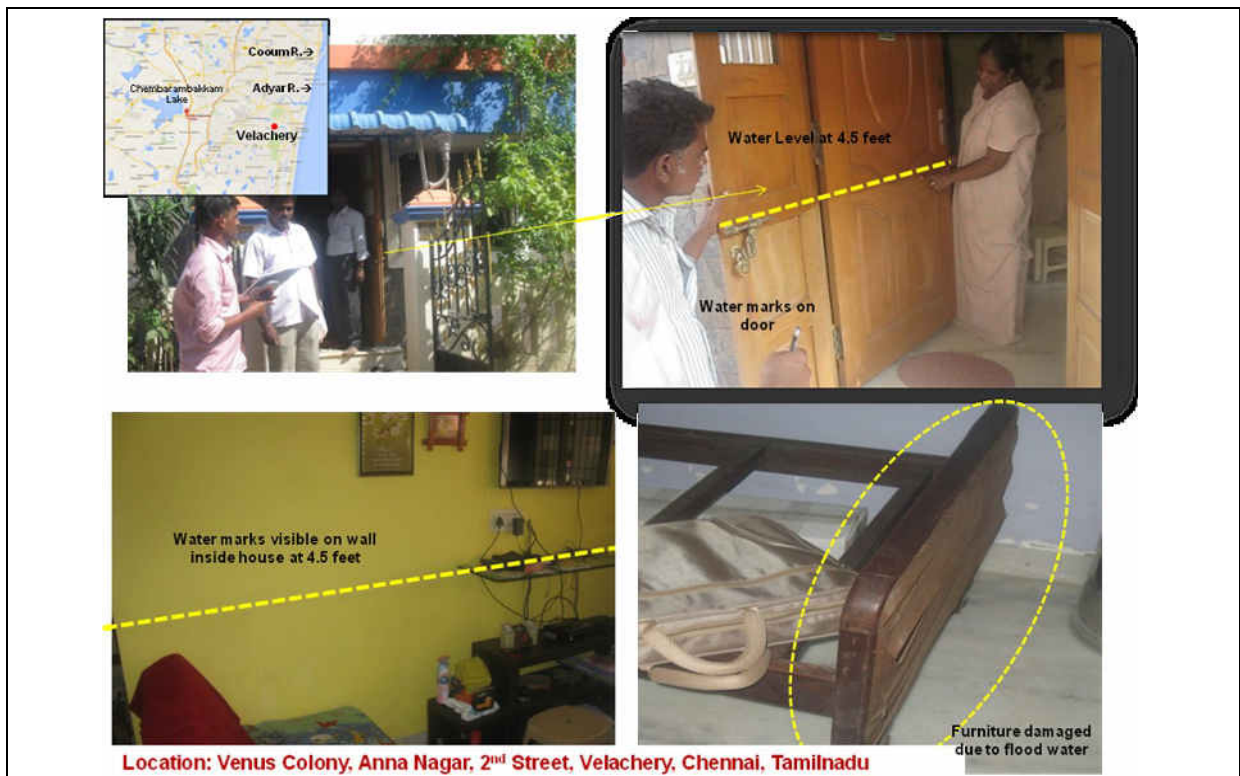
Fig-19 Flood water mark observed in doors, inside house and damage to furniture in one of the houses in Venus Colony, Anna Nagar, 2nd Street, Velachery. (c) NRSC/ISRO, 2015

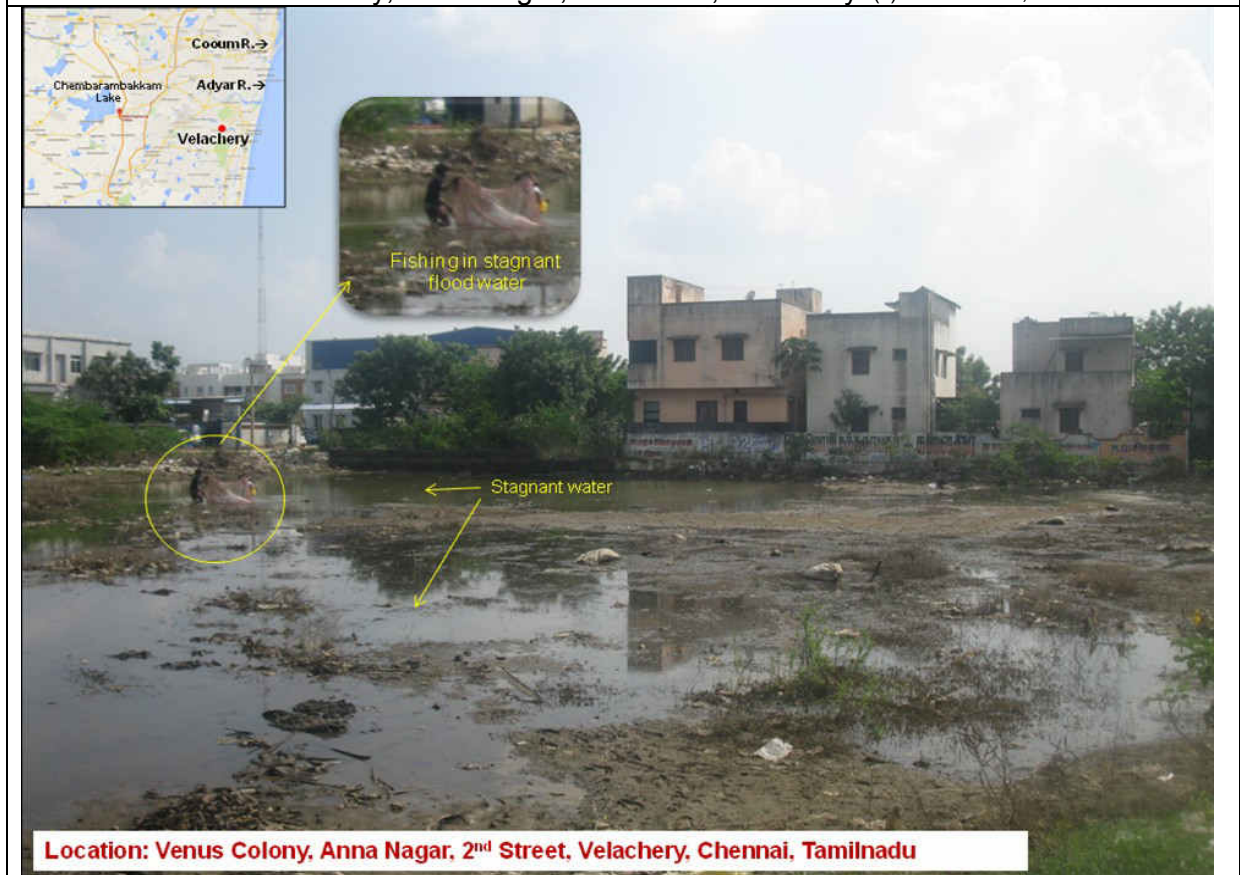
Velachery is a residential area in South Chennai, a metropolitan city in Tamil Nadu, India. The growth of Velachery during the last decade can be cited due to the growth of the IT sector in south Chennai. Velachery area is located about 2km south of Adyar River and is one of the worse affected locations. Flood water was stagnant in this area for almost 10 days causing maximum damage to houses located in this region. During field inspection the flood severity and flood waters persistence in this area could be observed from discolouration of the paint on doors, windows and meter boxes (wood made items) almost in all houses in Velachery (Fig-17, 18 & 19). The discoloration of the paint made a clear line indicating the depth to which the water had risen. Also the due to the submergence the water mark inside houses was also clear due to the moisture content well preserved. Average flood water depth observed was about 4.5-5 feet in this area. Due to flood waters all the household items especially electrical and furniture items were badly damaged (Fig-19). Waterlogging in many areas was observed during field visit in Velachery area (Fig-20).

Fig-20 Waterlogged area in Venus Colony, Anna Nagar, Velachery. (c) NRSC/ISRO, 2015

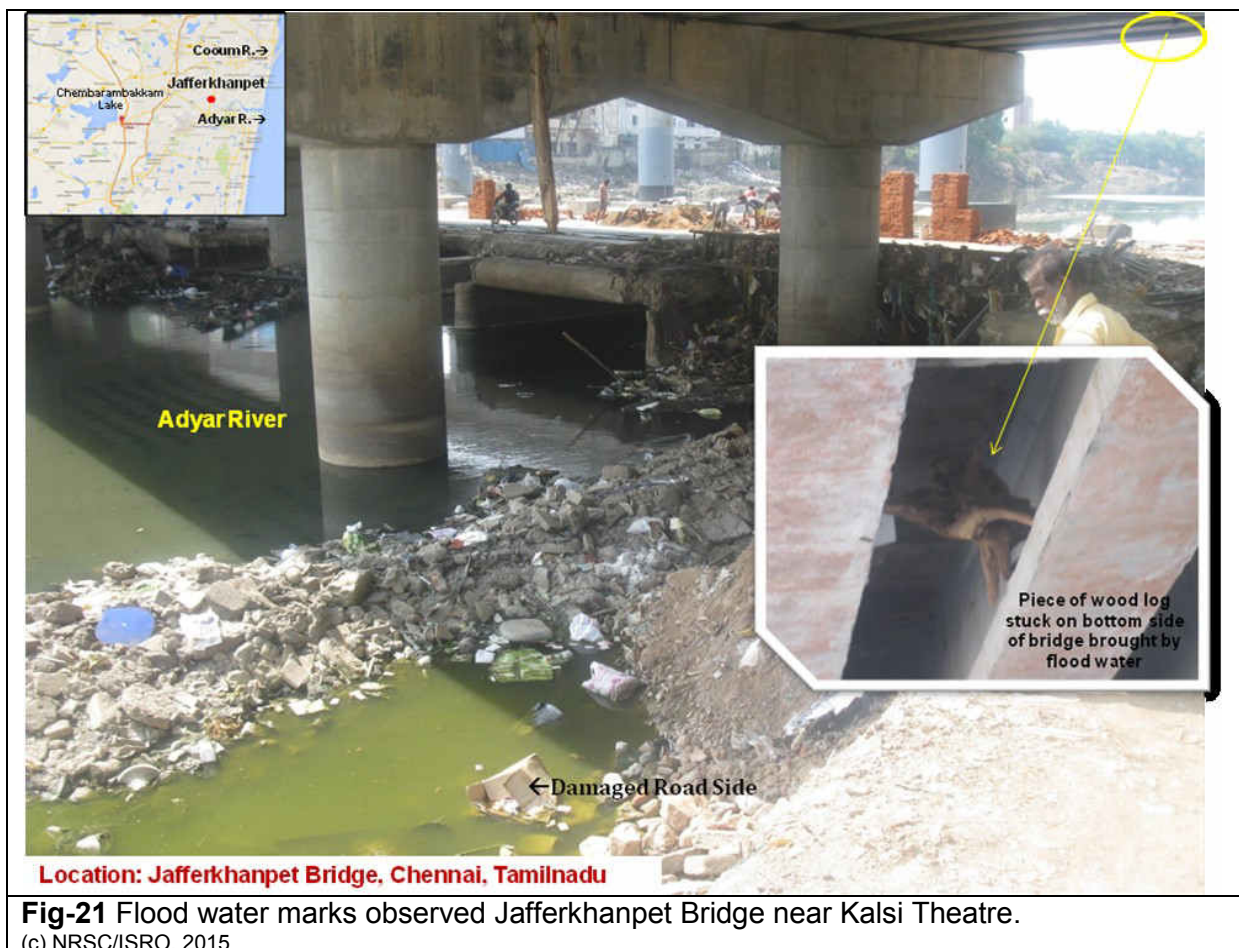
Jafferkhanpet is a locality of Chennai and Guindy, K.K. Nagar, Ashok Nagar, MGR Nagar, Saidapet is its neighbourhood suburbs. It is located about 0.2 km (aerial distance) north of Adyar River. Adyar River flowing below the Jafferkhanpet Bridge in this locality was in full spate with flood waters touching bottom of the bridge which must be at a height of about 20 feet. The wood, cloth and plastic pieces brought by the river can be seen clearly clinging on the bottom of the bridge alongwith water marks on the pillars supporting the bridge (Fig-21). The gushing flood waters had even damaged the road passing across the river and due to bank erosion side material caved in at many places blocking the flow of the water.

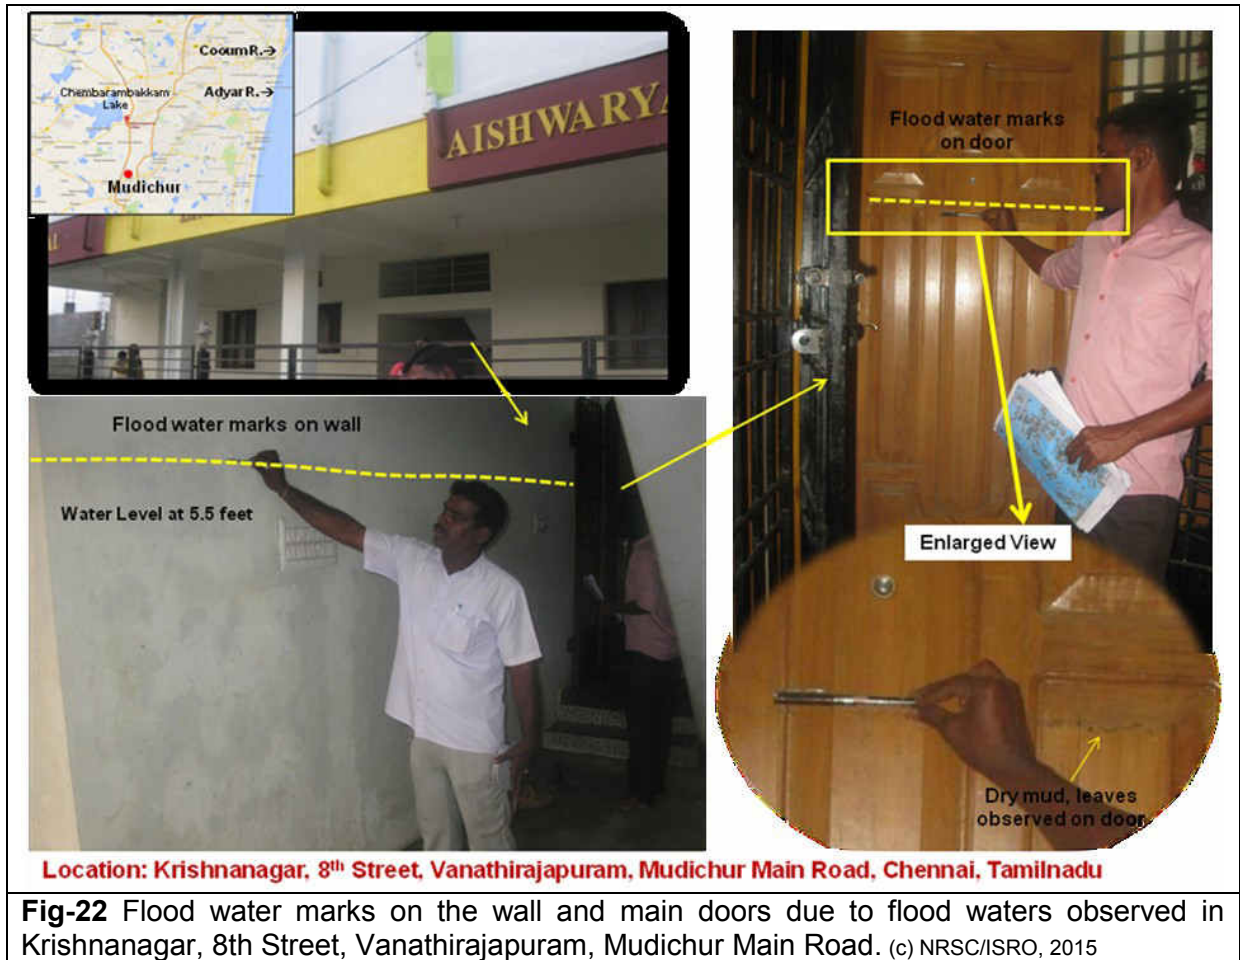
Mudichur area is located about 6km south of Adyar River. Flood water marks on the wall and main doors could be seen at a height of 5.5feet. Here the water marks are visibke with the sediments and small twigs clinging on the door (Fig-22).

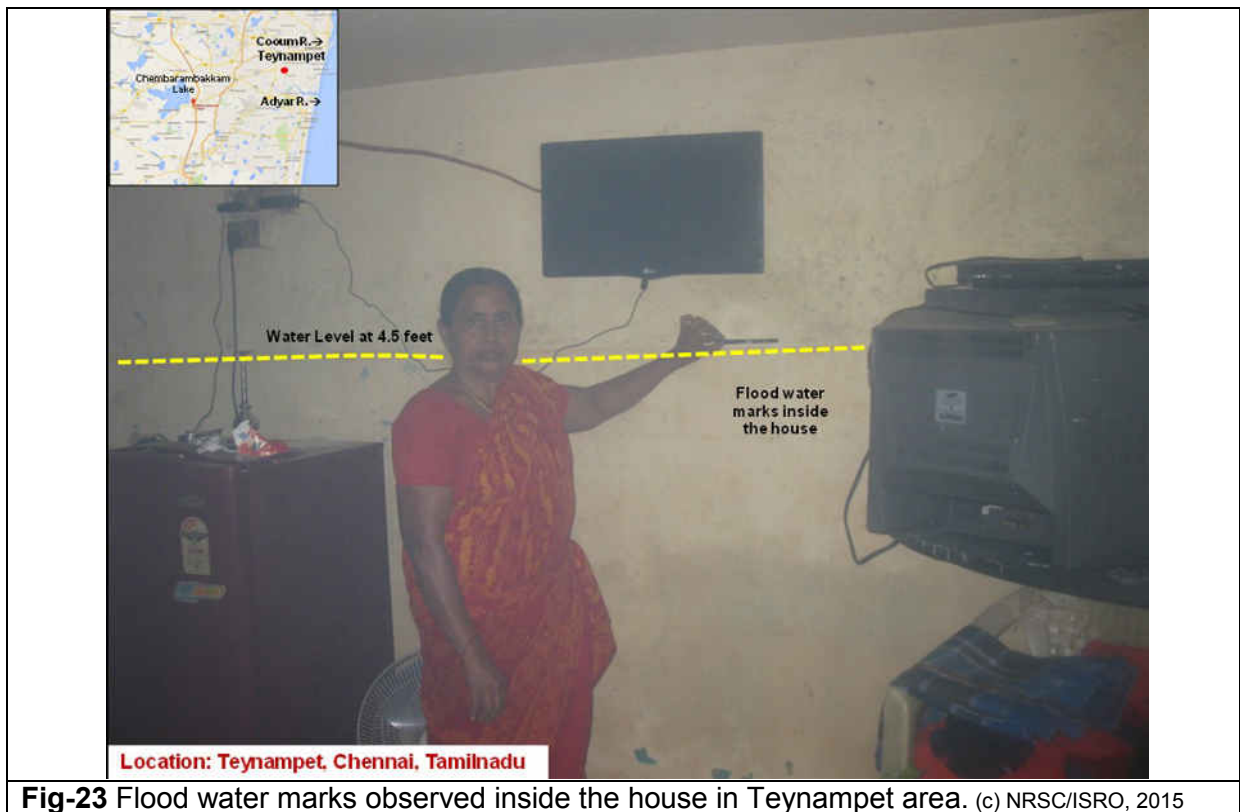
Teynampet is one of the busiest commercial localities in the city of Chennai. It is located about 2.5 km north of Adyar River. Here the average water depth in most of the houses was observed to be at 4.5 feet. Flood water marks inside the house walls could be prominently seen (Fig-23). This area was affected by flood waters on December 1, 2015 night and was under water for three days.

Fig-23 Flood water marks observed inside the house in Teynampet area. (c) NRSC/ISRO, 2015

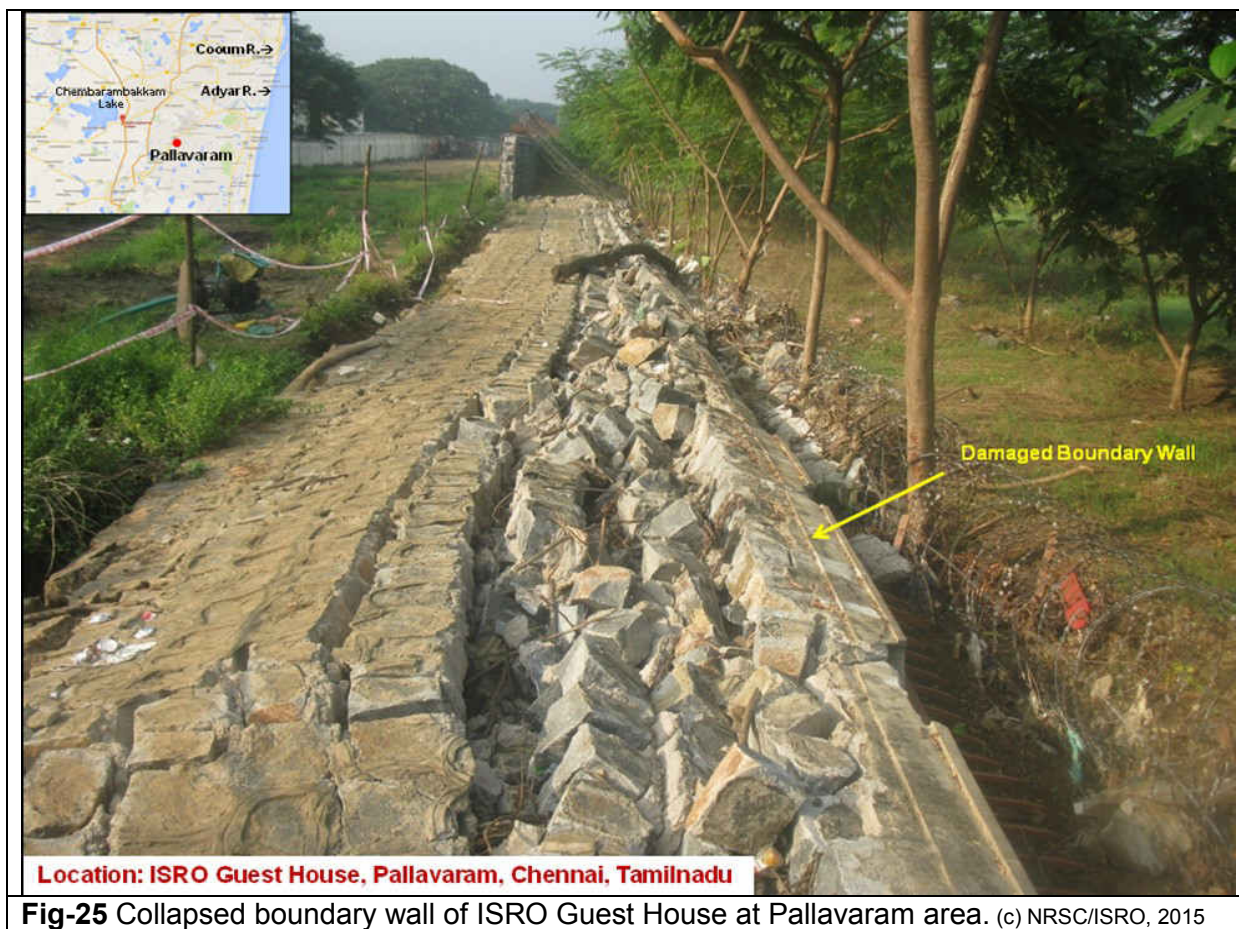
Pallavaram is a town and a selection-grade municipality located in the suburbs of Chennai. It forms a part of the Alandur taluk of Kanchipuram district and is located 17 kilometres from Chennai city. Pallavaram is known for its cantonment and bustling residential colonies. Pallavaram is located about 3.0 km (aerial distance) south of Adyar River. Here the floodwaters were observed to be at 1 feet and not significant inundation was caused in this area. However due to heavy rains waterlogging and damage to boundary walls was observed in some places (Fig-25).

Fig-25 Collapsed boundary wall of ISRO Guest House at Pallavaram area. (c) NRSC/ISRO, 2015
